1986 Nauticat 33 Motorsailer in winter trim
Prepared for John Corbett
129 Barton Avenue
Toronto ON M6G 1R1

John Bond Marine Surveyor SAMS®AMS®
Accredited Marine Surveyor Pre-purchase and Insurance Marine Surveys

SCOPE OF SURVEY Acting at the request of John Corbett, the surveyor did attend onboard the Nauticat 33 on June 13 2012 at Newcastle Marina Ontario, where an out of water inspection including the underwater machinery and the exterior of the hulls wetted surface was performed.

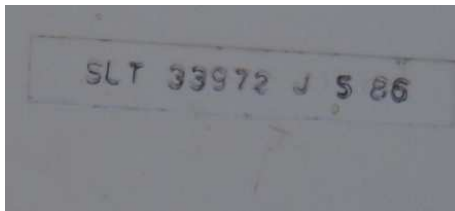
I certify that the hull identification number, which appears below on this document, was taken by the undersigned on the date entered below. SLT33972J586 (image has been cropped and contrast adjusted)

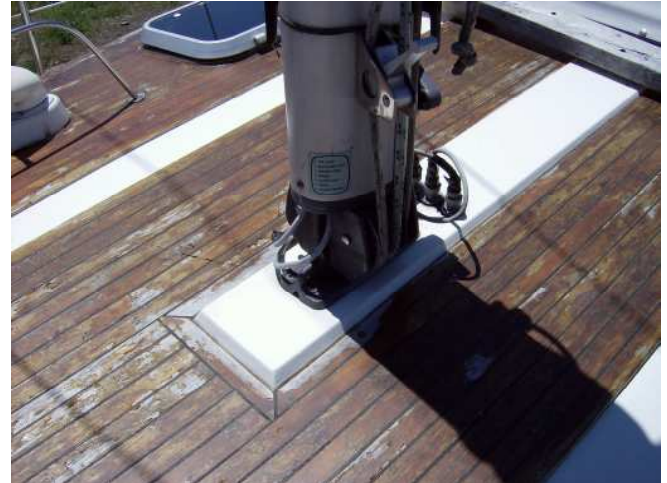
Mast mount

Two deck stepped aluminum masts with integral sail track, and aluminum spreaders supported by internal structure. No stress cracks were seen around the mast mounting. Tapped sound where tested. Booms were not onboard at the time of the inspection, gooseneck, and fittings inspected, serviceable.

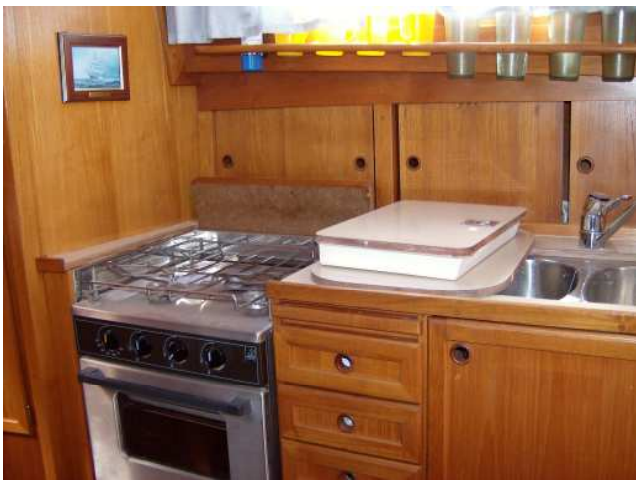
***B3** Galley contains a sink, cold pressurized water system, propane stovetop with oven, and a 12-volt DC fridge, model from tag SCSD-5405-A, using R 12 gas. Fridge was powered up, compressor heard. FRP, wood trim through out and upholstery are in good condition. Each area has ample 12-volt DC lighting.

Some 12-volt DC lighting is inoperable.

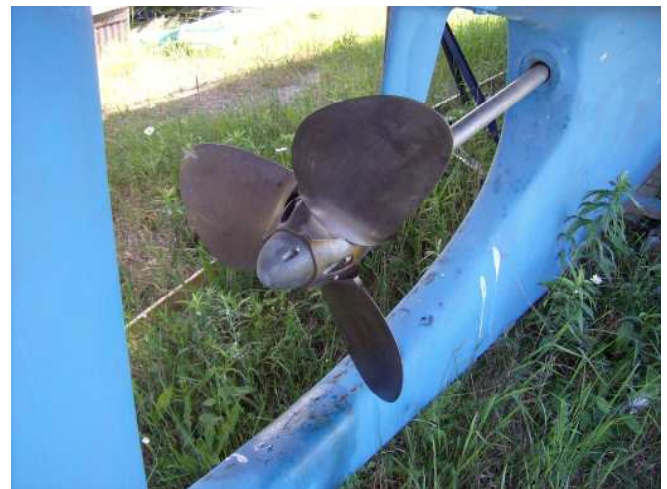
Propeller

One bronze three bladed propeller was visually inspected only, and found to be in usable condition. One 1 5/16' SS shaft, with hex nut packing gland attached to shaft tube with clamps and reinforced hose. Water lubricated cutlass bearing and bronze single strut. All appear to be in serviceable condition.
